# **DAMAGE MECHANISMS IN HIGH CYCLE FATIGUE**

By  
**David L. Davidson**

**AFOSR FINAL REPORT  
SwRI Project No. 18-8243**

**January 1999**

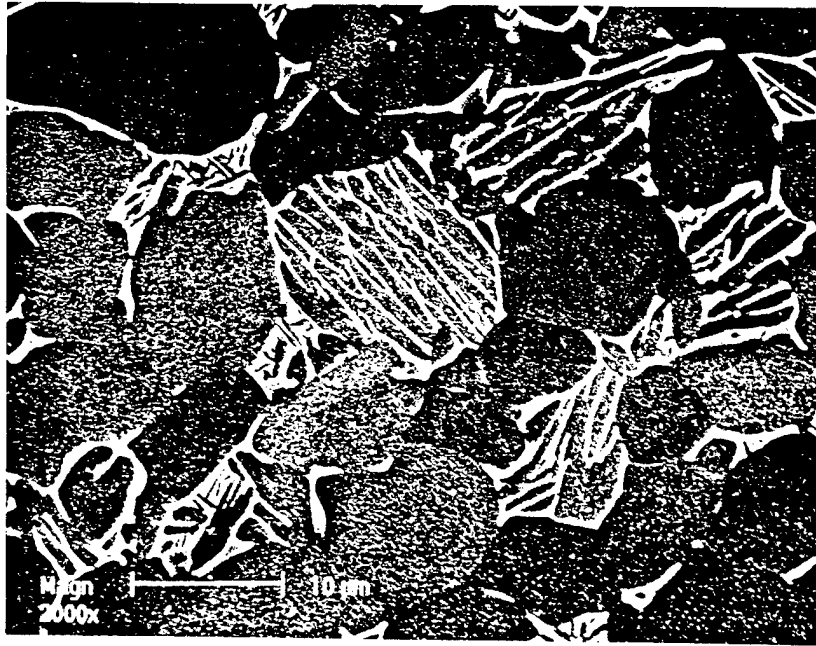
Fig. 1(a) Ti-6Al-4V forged and heat treated to give an equiaxed alpha-beta microstructure.

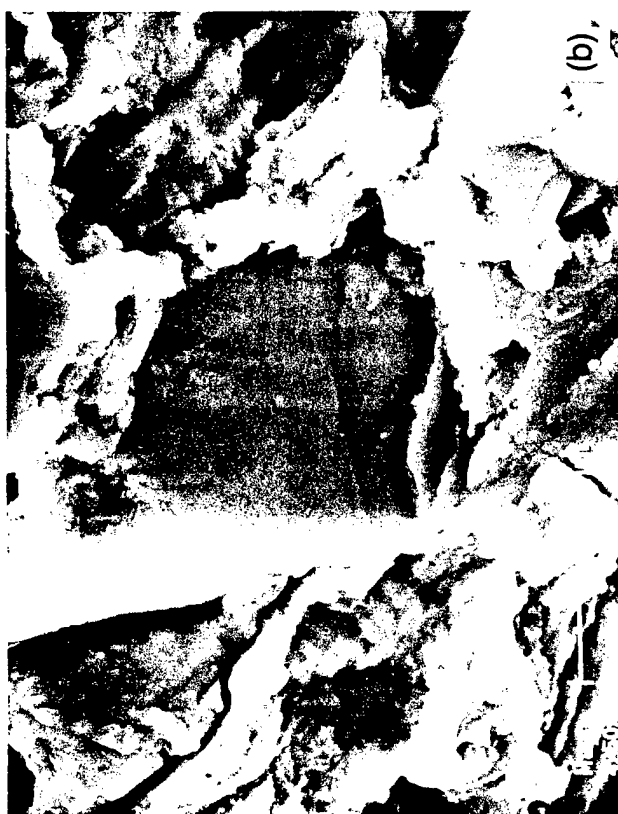
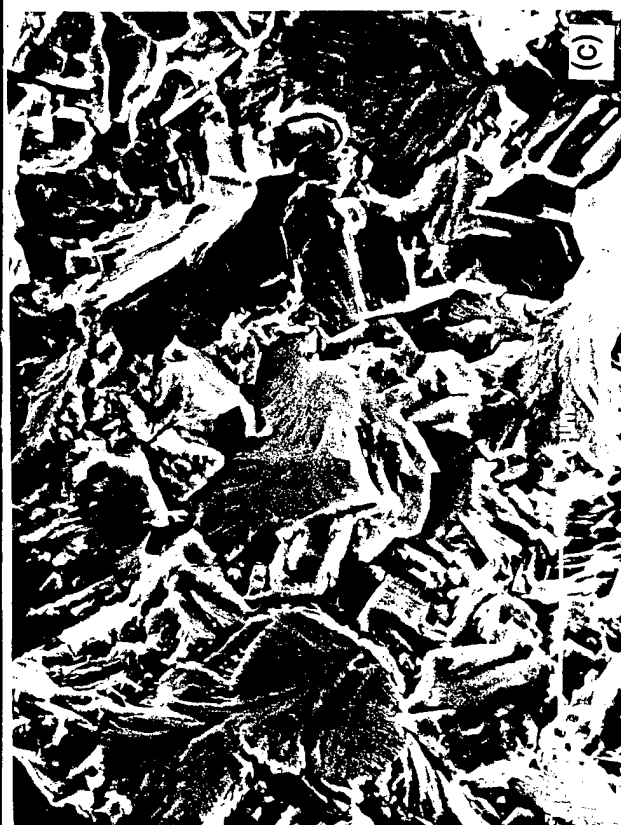
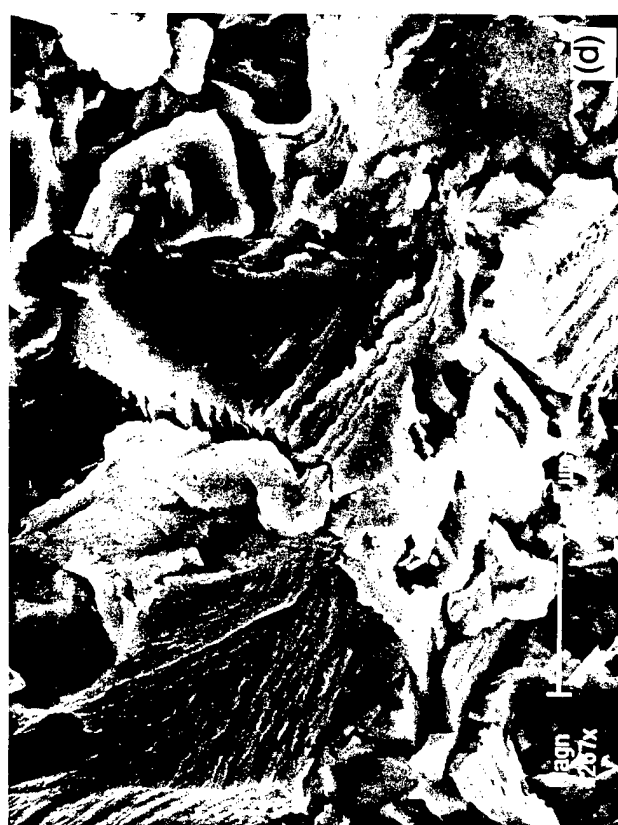
Fig. 12 Comparison of fracture surfaces produced by fatigue crack growth in (a,b) vacuum and (c,d) air. (a,b)  $\Delta K = 5.5 \text{ MPa}\sqrt{\text{m}}$ ,  $da/dN = 2 \times 10^{-11} \text{ m/cycle}$ . (c,d)  $\Delta K = 6.0 \text{ MPa}\sqrt{\text{m}}$ ,  $da/dN = 2 \times 10^{-9} \text{ m/cycle}$ . The flat facets are fractures of alpha titanium grains. Fracture of the transformed beta regions is much less planar.

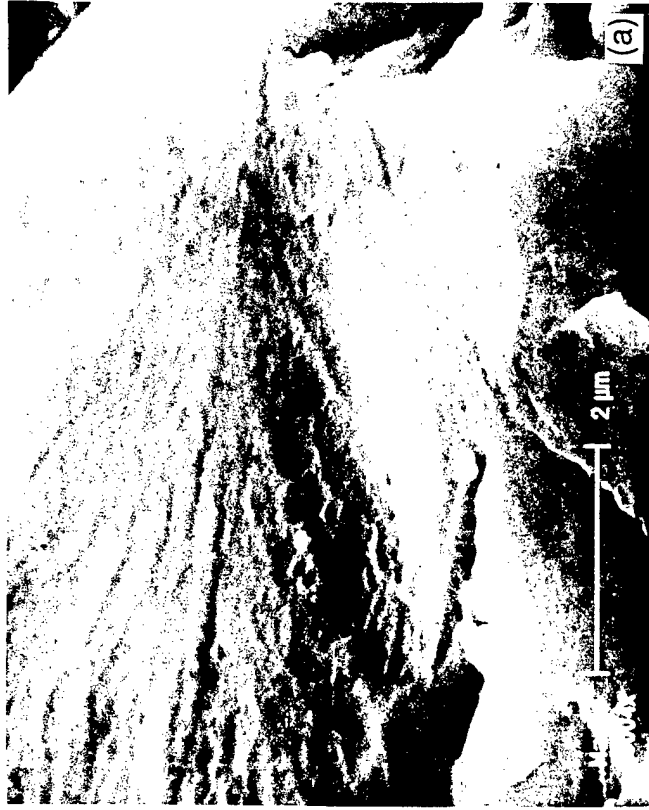
Vacuum:  $\Delta K = 5.5 \text{ MPa}\sqrt{\text{m}}$   
 $da/dN \approx 2 \times 10^{-11} \text{ m/cycle}$

Fig. 13 Fracture of alpha grains produced by fatigue crack growth in (a) vacuum showing river lines similar to those (b) made by crack growth in air. The features in vacuum have much less topography and are harder to detect. (a) Vacuum:  $\Delta K = 5.5 \text{ MPa}\sqrt{\text{m}}$ ,  $da/dN = 2 \times 10^{-11} \text{ m/cycle}$ . (b) Air:  $\Delta K = 6.0 \text{ MPa}\sqrt{\text{m}}$ ,  $da/dN = 2 \times 10^{-9} \text{ m/cycle}$ .

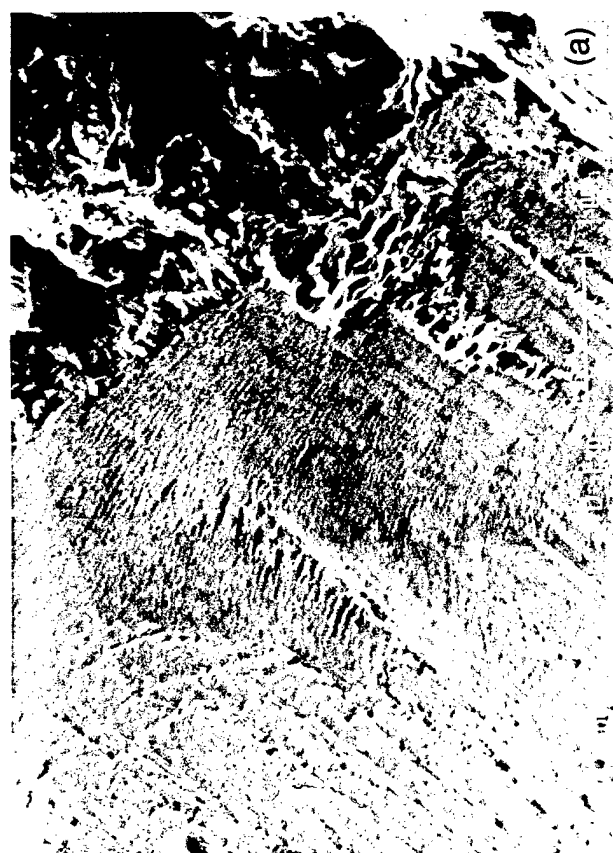
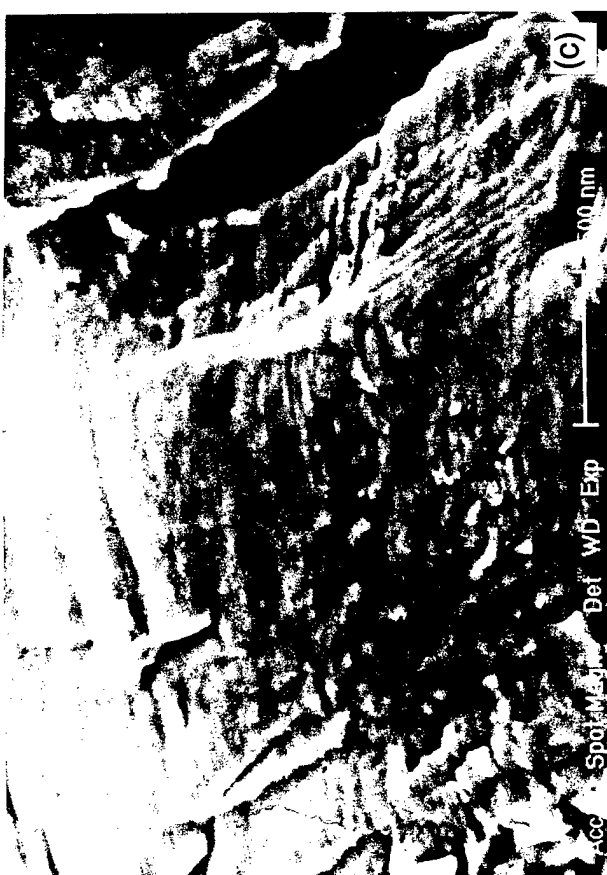
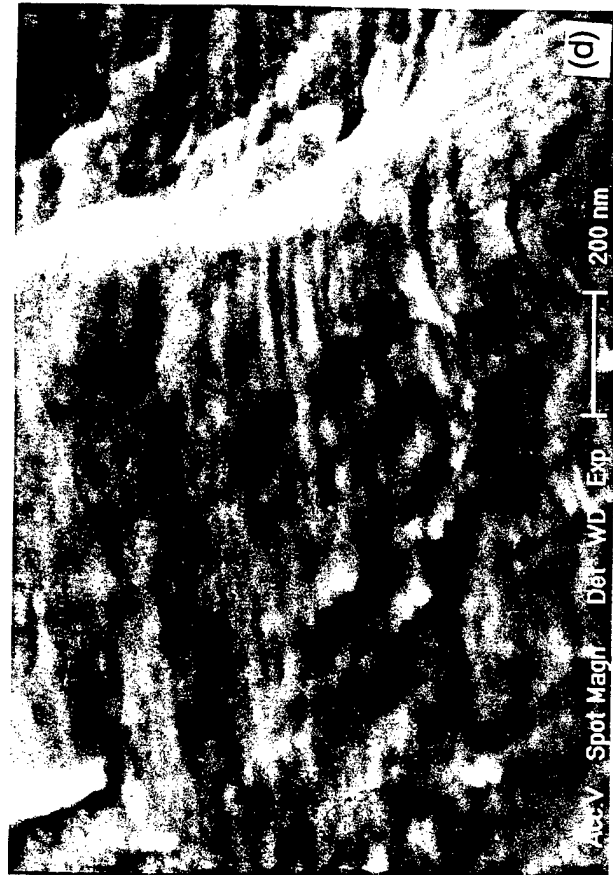
Fig. 14 Fatigue crack growth in air: (a) and (b) show striations formed on an alpha facet, while (c,d) show striations in a region of beta.

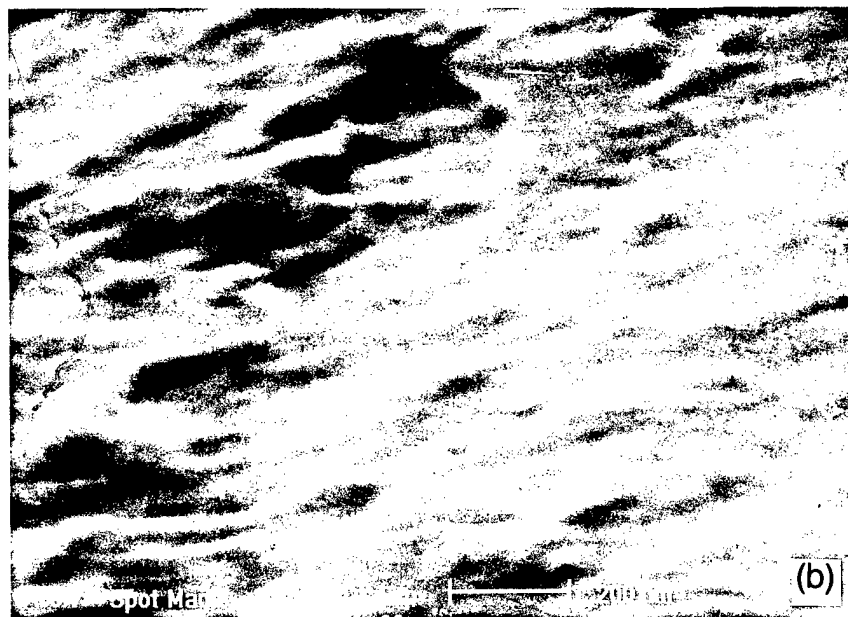
Fig. 15 Faint striations found on an alpha facet grown in vacuum. Magnification is the same as Fig. 16(b) for comparison.

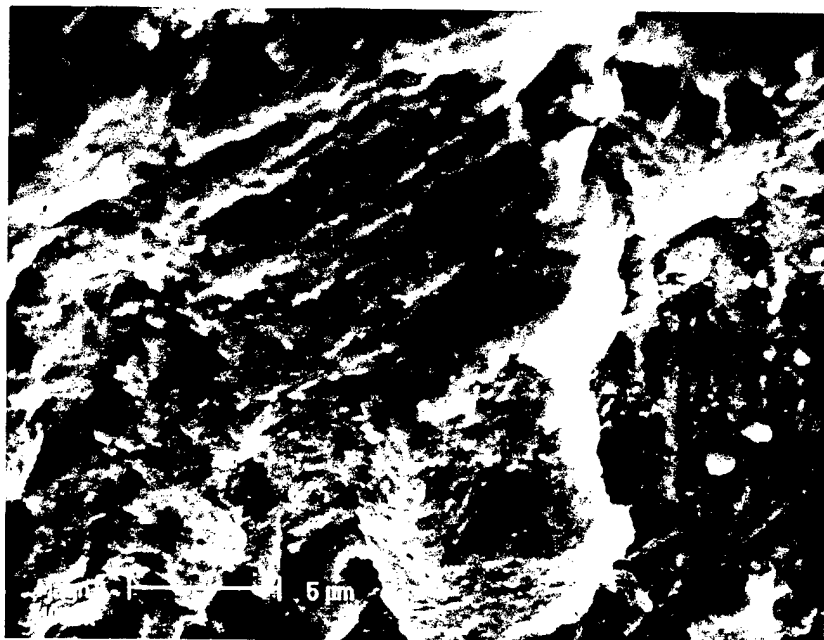
Fig. 5 Secondary electron image of the fracture surface shown in Fig. 4 about 0.4 mm from the origin. The parallel lines on the right are probably not crack arrest marks (striations), because they are regular and scale approximately with the lath width of the microstructure ( $0.4\text{ }\mu\text{m}$ ). However, the irregular parallel marks in the upper center probably are striations that have a spacing of about  $8\text{ }\mu\text{m}$ .
